# Vibration Induced Harness Failure Investigation

## ABSTRACT

## 2. FAILURE ROOT CAUSE ANALYSIS

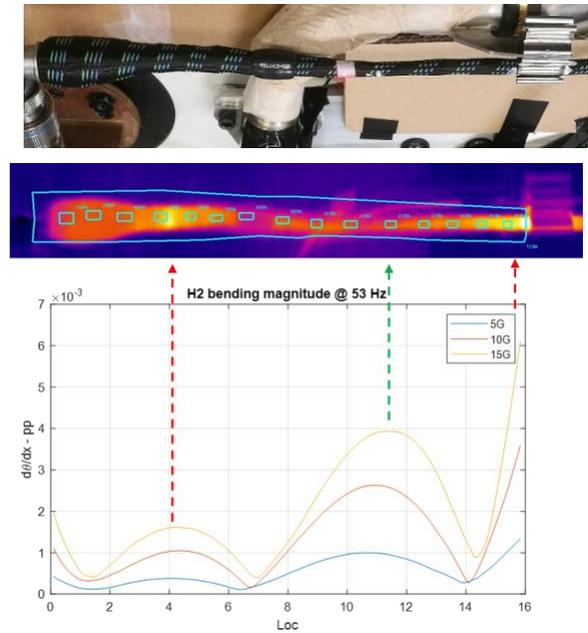
Figure 7(a). Thermal image and bending magnitude at 53Hz

The calculated bending magnitude and the corresponding thermal image at two modes – 53Hz and 228Hz – are shown in Figure 7 (a) and (b), respectively. It is very clear that there is a strong correlation between the high bending magnitude and the temperature rise at specific corresponding spots, which confirms the occurrence of the internal fretting, and temperature rise resulting from the vibration.

At 53 Hz, there are three locations with high bending magnitude – Loc 4, 10, and 15. Loc 4 is at the end of the taper joint from the connector to the harness wire, and Loc 15 is at the clamp location. Due to the internal structure, the bending stiffness at Loc 4 is relatively low compared to the adjacent harness, so called kink spot. In the thermal image, there are two hot spots – Loc 4 and 15, and Loc 10 is relatively cool. The temperature rise is affected by three factors: sliding speed, and contact pressure. The sliding speed is determined by the bending magnitude, the frequency and the distance from the sliding layer to the neutral axis /diameter of the harness. At Loc 10 and 15, the diameter is identical, Loc 15 shows a higher temperature due to the higher local bending magnitude. At Loc 4, the bending magnitude is lower than Loc 10 and 15, while the sliding speed and contact pressure are relatively high due to its larger diameter, therefore the temperature is high.

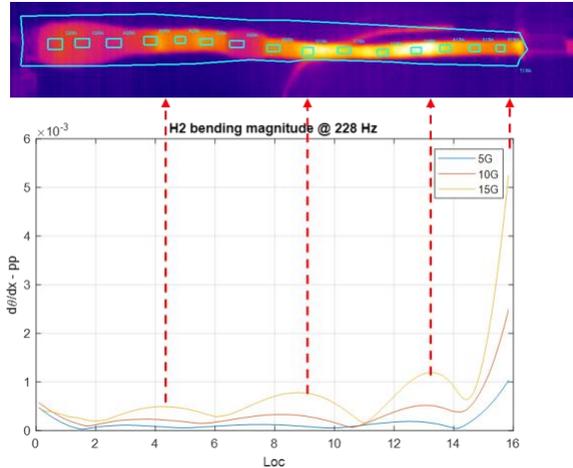
Figure 7(b). Thermal image and bending magnitude at 228Hz

At 228 Hz, there are four high bending areas, each area coincides with a hot spot. The bending magnitude is lower than that at 53Hz in general, however the temperature rise is still high, which can be seen later. It is driven by a higher sliding velocity, which is proportional to the frequency.

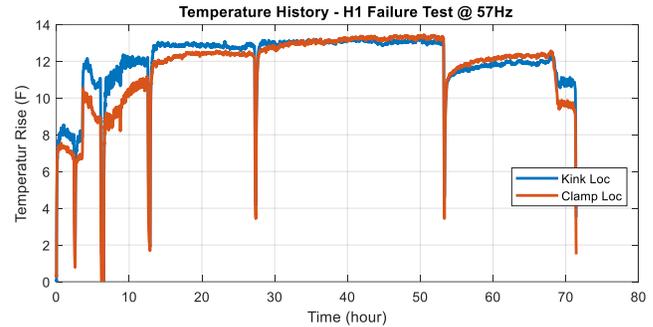
Figure 8. Temperature rise history of H1 failure test

The first harness H1 is tested at 57Hz, the excitation level is set at 15G. The time history of the temperature rise is shown in Figure 7. Loc 4 (kink location) and 15 (clamp location) show the highest temperature rise with respect to the room temperature, which can reach 13 F. The temperature dips are a result of the test breaks for the static resistance measurement. The temperature remains relatively stable over the entire test.

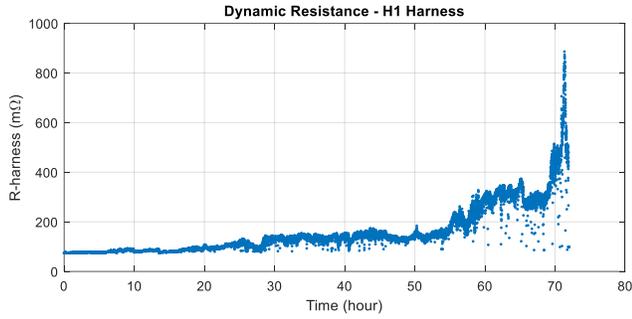
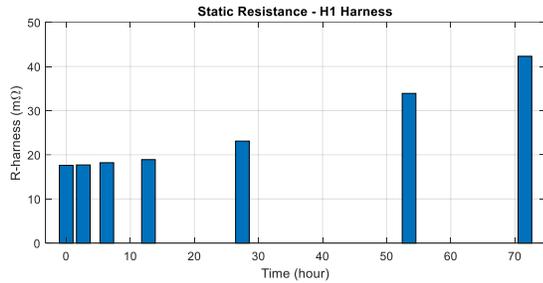
The dynamic and static resistance measurement are shown in Figure 9(a) and (b), respectively. The dynamic resistance includes the resistance of the connection wires to the Wheatstone Bridge, so it is higher than the static value. The resistance is relative flat prior to 55 hours. After that it began to gradually increase. After 65 hours, the resistance reading begins to take off. At 72 hours, the dynamics resistance is very high and the static resistance readings confirms the actual resistance increased by 170%. The harness is claimed ‘failed’ and the test is stopped. The trend of the dynamic resistance shows good agreement with the typical mechanical system failure trend. Over the 72 hours test, it accumulated 15 M cycles.

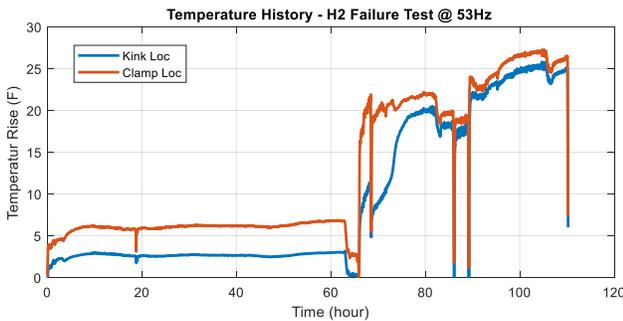
Figure 10. Temperature rise history of H2 failure test

The second harness H2 is tested at 53Hz, the excitation level is initially set at 15G as H1 test. After 64 hours, no resistance increase is observed. Then the excitation level is increased to 25G. The test lasted for another 48 hours until the static resistance increased by 140%. The time history of the temperature rise is shown in Figure 10. At 15G excitation, the temperature rise at kink location is only 3 F, much lower than 13F in H1. The lower temperature indicates less friction induced heat and less fretting. Therefore, H2 does not show any sign of failure in the dynamic resistance at 50~60 hours like H1 did. When the excitation is increased to 25G, the temperature rise jumps up to 20~25F, and the harness fails in 48 hours. From H1 and H2 test, it clearly demonstrates that the temperature rise is a good indicator of the severity of the fretting.

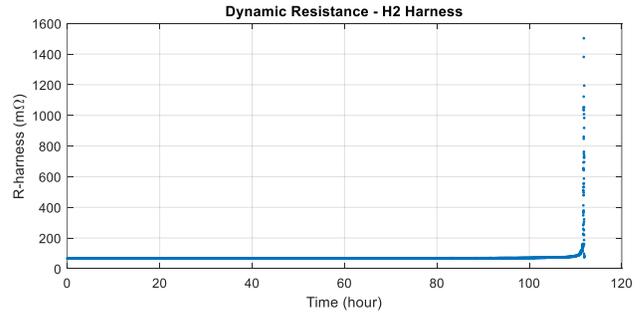
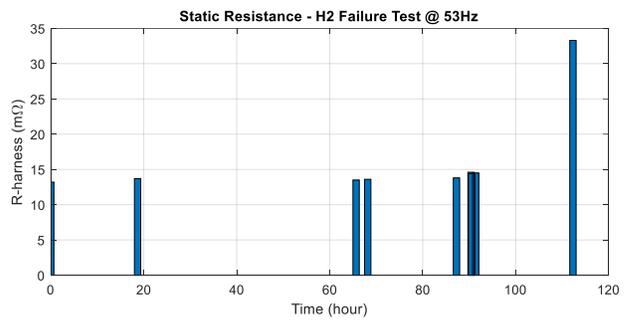
The resistance measurement of H2 test is shown in Figure 11. The resistance maintains unchanged prior to 110 hours, after then it takes off with a sharp rise.

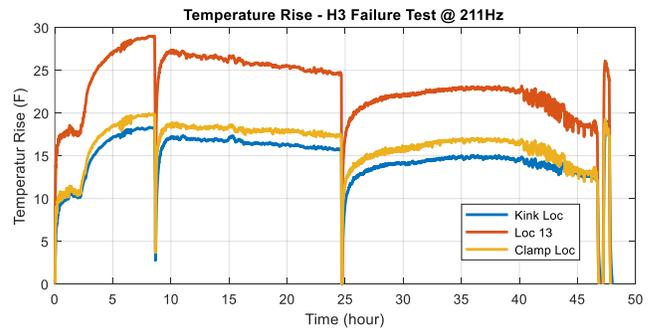
Figure 12. Temperature rise history of H3 failure test

The third harness H3 is tested at 211Hz. The excitation level is set as 15G. The time history of the temperature rise of the harness with respect to the ambient temperature is shown in Figure 12. The harness H3 shows a temperature rise over 28F at Location 13, which is twice of H1 test. While the bending magnitude at 211 Hz is lower than that at 53Hz, as shown in Figure 7(b). The higher temperature is caused by a higher sliding speed due to a higher frequency.

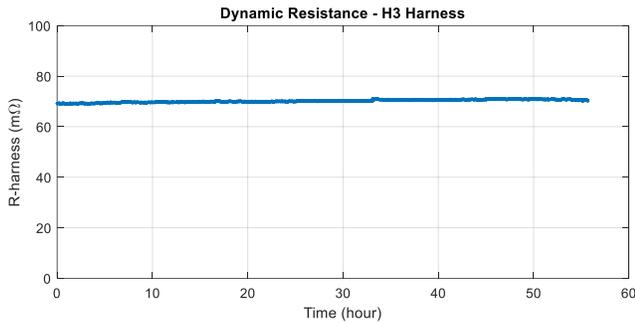
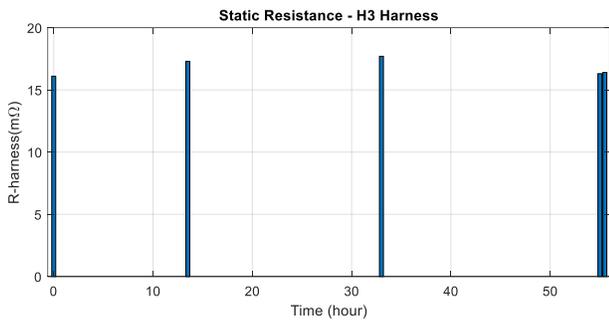
The test lasted about 55 hours and accumulated over 40 million cycles in total. The dynamic and static resistance measurement are almost unchanged as shown in Figure 13.

Therefore, the test is stopped, and the harness is determined as no damage.

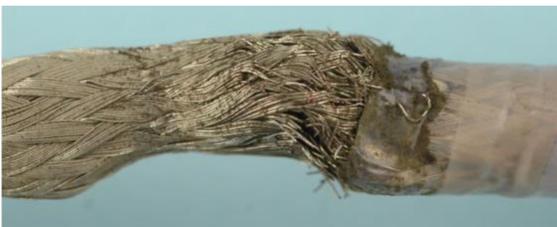
Figure 14. Actual wire damage after teardown of H1

After the accelerated failure test, the harness H1 is CT scanned to inspect the braid shielding integrity, which reveals the wire break within the braid shielding. Finally, the harness is teardown, and the actual damage is confirmed, as shown in Figure 14. There is extensive wire break within the shielding, accompanied with the metal debris and discoloration, as expected.

The accelerated failure test confirms the failure mode, which is the wire abrasion and fretting in the metallic shielding induced by vibration. The harness segment from the sensor to its first clamp location is subject to a higher risk of failure, where the bending mode is in the low frequency range. Within this segment, the failure tends to occur at the end of the taper ramp/kink location, where the bending stiffness is lower than the adjacent section. The other important observation is that temperature rise is a good indicator of the wire sliding, but it can only serve as a 'partial' indicator of the abrasion/fretting. The contact pressure is another key factor, which has different level of impact on the heat generation and fretting/abrasion. The test indicates that the low frequency bending mode has the highest potential of causing failure.

Further, to mitigate the failure risk due to fretting, there are two general approaches. One is to improve the harness design to eliminate the "kink" spot. The other is to change the harness layout to suppress the vibration. For example, a simple solution is to reduce the harness span to increase the frequency of its first bending mode. A series of test have been conducted by varying the harness span and the effectiveness has been confirmed.
