# Analyzing Imbalance in a 24 MW Steam Turbine

Imbalance in critical rotary equipment is one of the most important factors, which should be controlled to prevent great damages. In this case study we are discussing about a 24 MW steam turbine, which drives a propane compressor. The radial vibration on the DE side of the turbine was growing gradually to a high level close to the alarm's value. Using FFTs, time signals, orbit diagrams, and phase measurement led us to believe that the rotor became imbalanced. After tripping and disassembling the turbine, we found out, some blades of the impulse stage of HP section got broken. Changing the rotor with the spare one, and repair the damaged rotor, worked out. It was concluded that using the vibration analysis technique is an effective method to find critical rotating equipment's faults at the earliest levels. And performing the essential correcting tasks to prevent secondary damages and specially decrease of production.

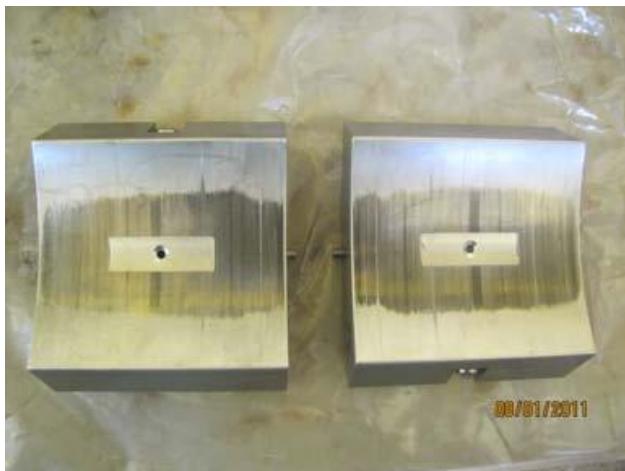
In 14 Jan 2011, radial vibration values on turbine DE bearing increased a little. Then data acquisition from online monitoring system began to gather FFTs for precise analyzing. Visit the bearing in early August 2011 assure us that it could not be the source of high vibration level.

Figure 2. Not severe pitting (permissible clearance)

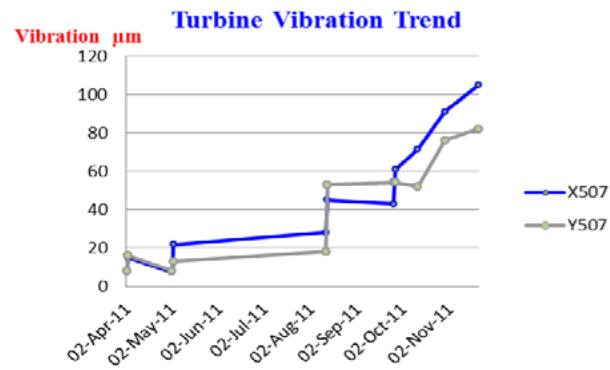
Gathering FFTs; time waveforms; orbits and phase values, led us to believe that, rotor might have imbalance or bent shaft defect. Meantime we discovered that X507 was the most important and variable value.

Figure 3. Vibration trend DE bearing

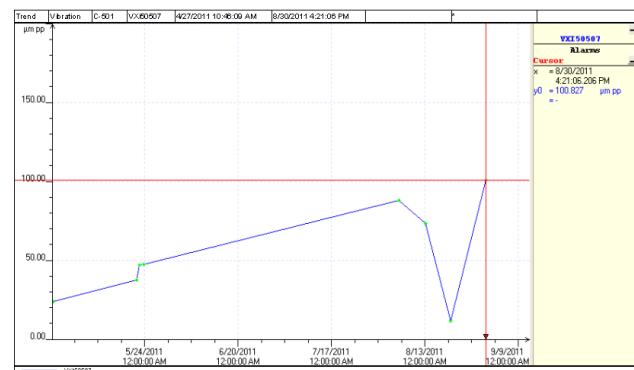
Figure 4. Vibration X507

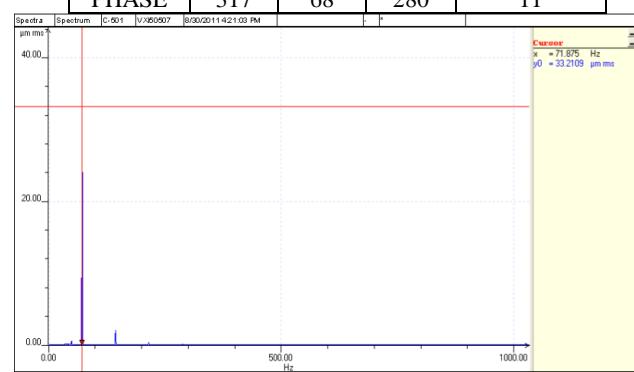
Figure 5. X507 FFT (Obviously 1\*rpm excited)

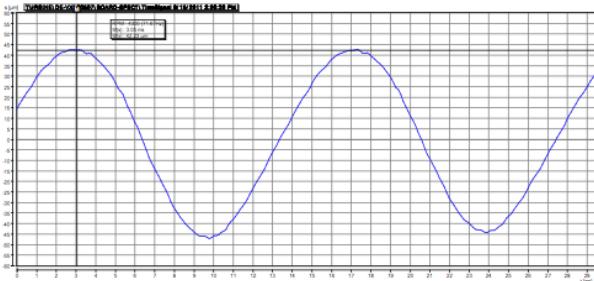
**Figure 6. X507 Time Waveform (Absolute Sinusoidal)**

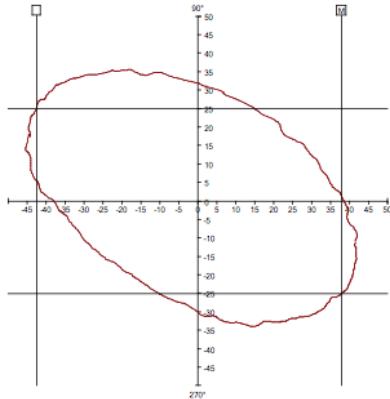
**Figure 7. X507 Orbit diagram (Absolute Elliptical)**

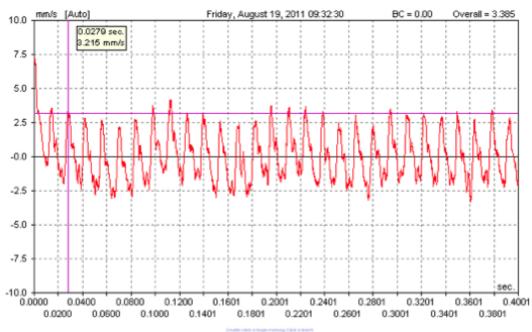
**Figure 8. Turbine NDE Synchronous Time waveforms**

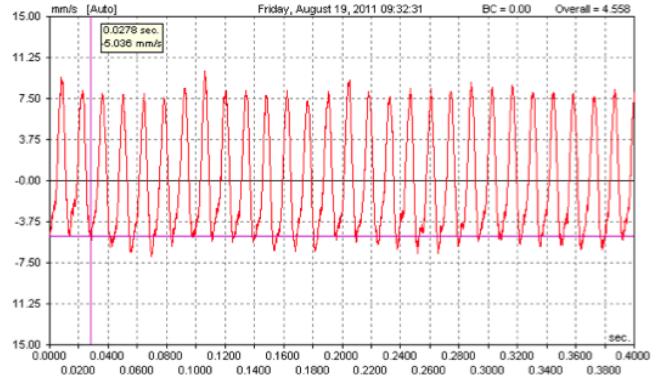
**Figure 9. Turbine DE Synchronous Time waveforms (180° Phase difference)**

As for 180-degree difference in axial measurement directions; the axial phase difference between turbine DE and NDE bearings is zero. That means the bent shaft theory is rejected. Accordingly imbalance was the final diagnosis. Eventually when vibration level on X507 was about 122  $\mu\text{m}$ , turbine was tripped and disassembled so we saw that some blades of the impulse stage for HP section was broken.

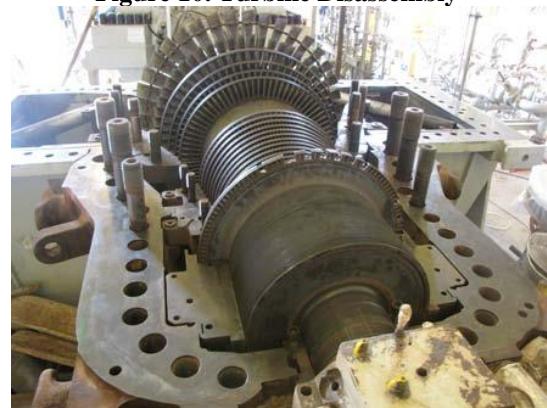
**Figure 11. Hp Broken Blades (Full shot)**

By changing the rotor, the vibration levels lowered to near its initial values. And the damaged rotor was sent to shop for repairing.

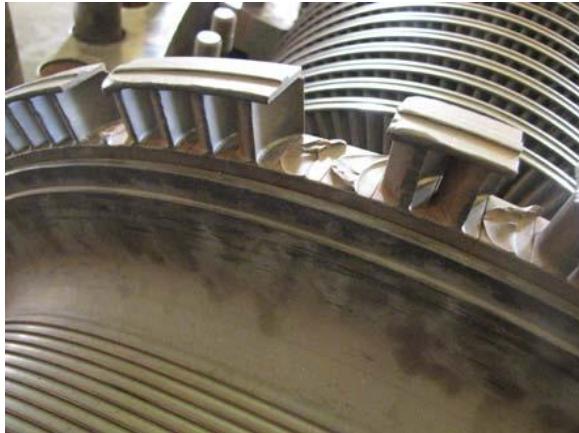
**Figure 12. Hp broken blades (Detail shot)**
