Fault Detection based on MCSA for a 400Hz Asynchronous Motor for Airborne Applications

In this paper, transferability to airborne applications, where the power supply is 400Hz, is assessed. Three phase asynchronous motors are used to analyse detectability of different motor faults. The possibility to transfer fault detection results from 50Hz to 400Hz induction machines is the main question answered in this research work. 400Hz power supply frequency requires adjusted motor design, causing increased motor speed compared to 50Hz supply frequency. The motor used for experiments in this work is a 800W motor with 200V phase to phase power supply, powering an avionic fan. The fault cases to be examined are a bearing fault, a rotor unbalance, a stator winding fault, a broken rotor bar and a static air gap eccentricity. These are the most common faults in electrical induction machines which can cause machine downtime.

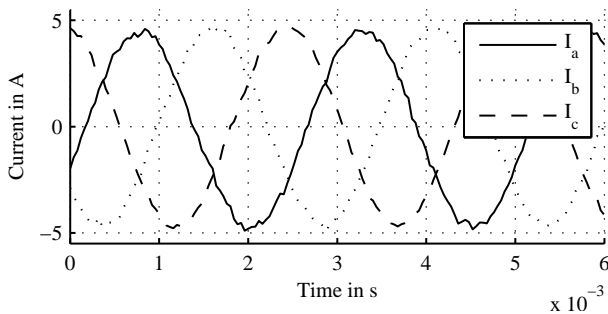
Figure 1. Measured current signals of all phases

An example of the measured current signal of all three phases is shown in Figure 1. The signal to noise ratio (SNR) of the measured data is $SNR > 600$, providing measured data with sufficient accuracy.

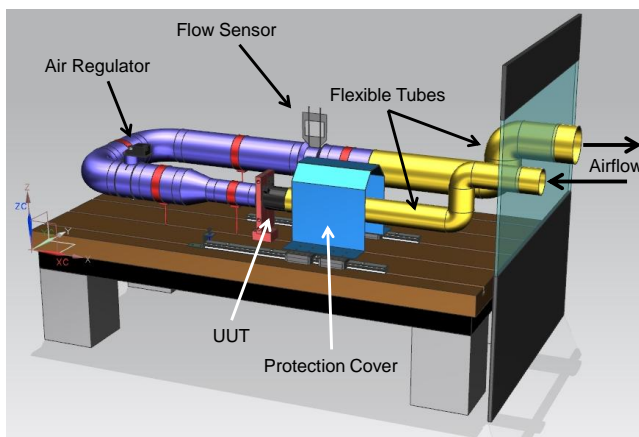
The test rig is powered using a variable voltage, variable frequency power supply. It is set to 115V line to ground which is 200V line to line and synchronised at a phase angle of 120. The motor is a three phase wye-connected asynchronous motor with no neural wire. The motor powers a fan, consuming approx. 800W under normal condition. During run-up, the motor consumes more power but this operating point is not considered in the following analysis. The motor has a rated speed of 11300rpm which is approx. 188Hz. The fan is installed in an open tube system with the in- and outflow connected to outdoor air. The inflow tube is flexible, which is a realistic assembly. Behind the fan, an air regulator is used to control the airflow to a constant of 235 liter per second. The airflow is measured using a flow sensor. The air flow is controlled using a PI feedback controller. All experiments are carried out at a constant set point of 235 l/s, if not mentioned otherwise. The speed sensor is integrated in the motor, supplied by the manufacturer. The complete test rig installation is attached to a machine test bed. A schematic picture of the test rig with installed motor (Unit Under Test, UUT) is shown in Figure 3. The protection cover is installed for safety reasons.

Figure 3. Schematic picture of the test rig

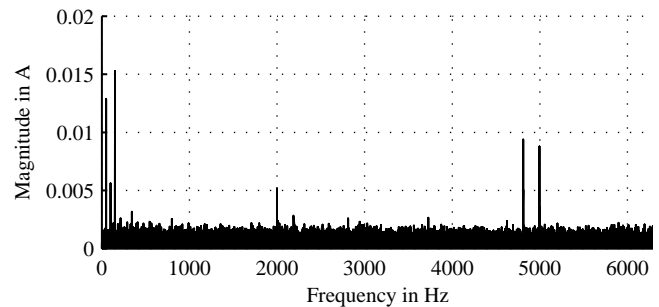
First, the spectrum of one motor in delivery state is discussed. In subsection 4.1, the differences of the spectra from different motors in delivery state are examined. Figure 4 shows the Fourier spectrum of one motor (index #1) in delivery state. Only the frequencies up to 6kHz are considered since no peaks appeared above in this entire analysis. The magnitude peak at exactly 2kHz is produced by the power supply and is therefore not discussed any further. The power supply also

Figure 4. Spectrum of motor in delivery state

To be further mentioned, the frequency spectra show sensor noise with approx. 2mA. This makes all peaks below 2mA being interpreted as sensor noise. This can be seen e.g. in Figure 4.

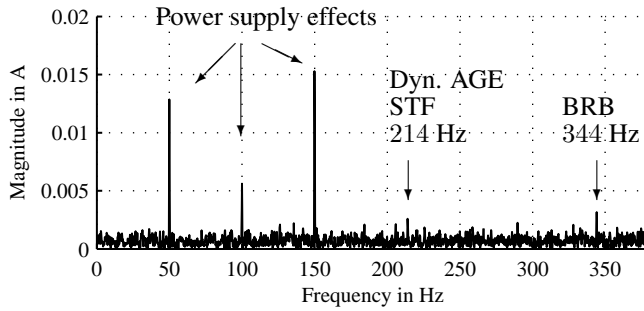
causes peaks at 50, 100 and 150Hz. These peaks are shown in Figure 5, where the frequency axis is cropped from 0 to 380Hz. These peaks are not further considered since they appear in every measurement and are not caused by motor effects but by the power supply. In this frequency range, characteristic fault frequencies which proved to be of great interest in this research work appear at 214 and 344Hz, as marked in the graph. The peak at 214Hz appears in the characteristic fault frequencies of the stator winding fault (STF) and of the dynamic air gap eccentricity (AGE). The peak at 344Hz belongs to the characteristic fault frequency of the broken rotor bar (BRB) fault. Explanations and formulas for the respective characteristic fault frequencies are given in section 5.

Figure 5. Delivery state, 0 to 380Hz

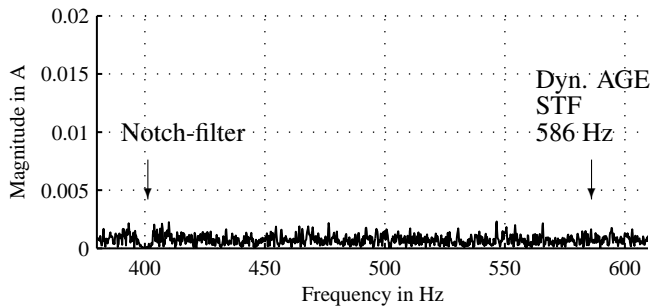
The frequency range between 380 and 600Hz is shown in Figure 6. The effect of the notch filter at 400Hz is obvious, no measurement noise is visible at this frequency and the supply frequency is efficiently damped. Another important frequency is at 586Hz, where also characteristic fault frequency

Figure 6. Delivery state, 380 to 600Hz

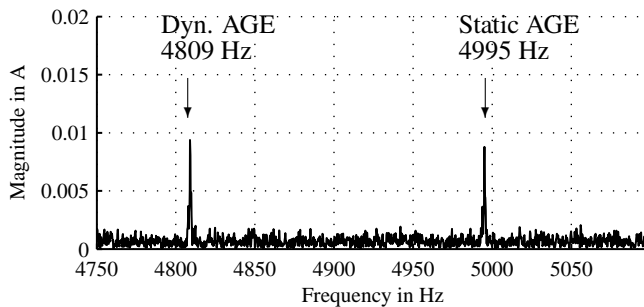
delivery state show nothing but measurement noise in the range from 586Hz to approx. 4800Hz. Important peaks in the Fourier spectra are found around 5kHz, as shown in Figure 7. The peaks at 4809Hz appears in the dynamic- and the peak at 4995Hz in the characteristic fault frequency of the static AGE. Dynamic AGE can e.g. be the result of an unbalanced rotor. Both peaks are appearing in most spectra, also in those of motors in delivery state.

Figure 7. Delivery state, 4800 to 5100Hz

Finally it has to be mentioned, that in some cases the motors in delivery status show a significant peak at this frequency, see e.g. Figure 7 for motor #1. In this test run, the magnitude at approx. 5000Hz is almost as high as the one in this chapter for test scenario #3. Due to the exact motor housing, no further deflection of the front bell could be achieved since the fan would scratch on the motor housing. The damage level in these tests was very low, nevertheless, the static AGE fault can be detected.

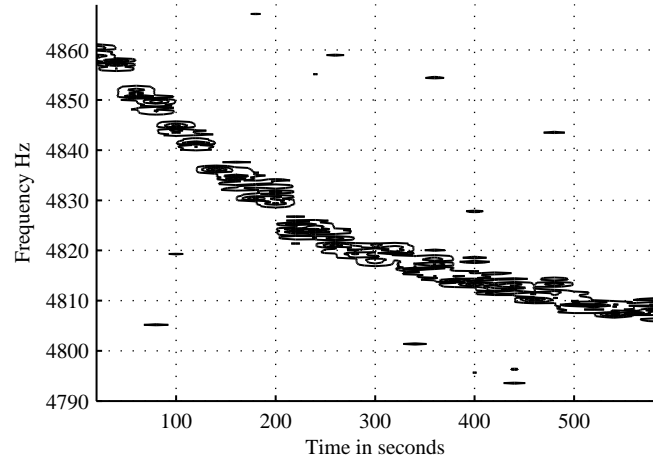
Note that most peaks of the characteristic fault frequencies are dependent on the rotor speed. An example is the peak of the dynamic AGE fault at approx. 4800Hz. Figure 8 shows

these peaks of consecutive measured spectra in the frequency range of this characteristic frequency, as viewed from the top of the spectra. It is clearly visible that the frequency of the peak shifts over time. The frequency converges after approx. 400 seconds. The additional lines appearing in the plot are the result of sensor noise and are of no interest. Therefore, the

Figure 8. Shifting of dynamic AGE peak due to changing rotor speed

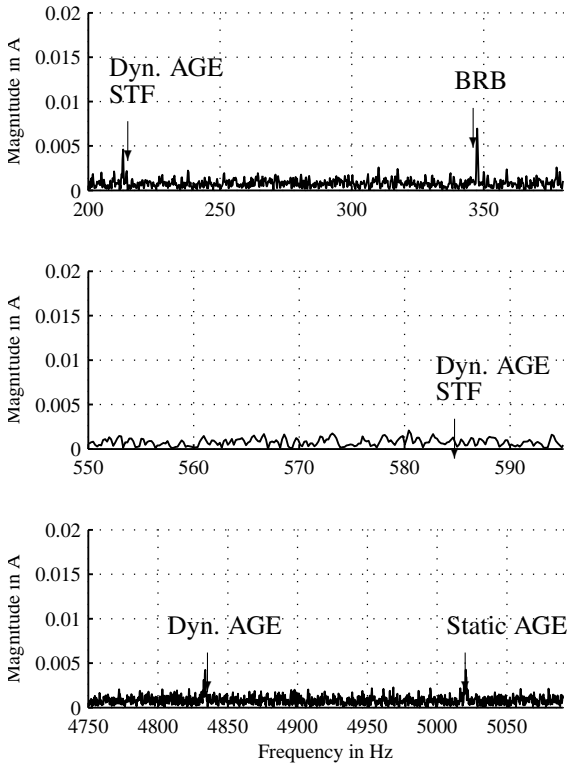
Figures 9, 10, 11 show the frequency ranges of interest for the motors #2, #3, #4, respectively. The frequencies where peaks

are appearing or expected are marked. These plots clearly show the differences in the current amplitudes for the different motors.

Figure 9. Spectrum of motor #2 in delivery state

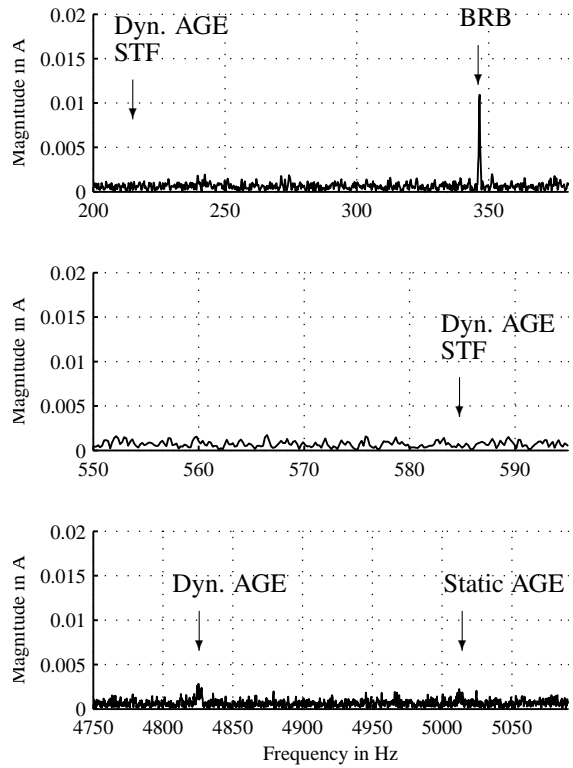
Figure 10. Spectrum of motor #3 in delivery state

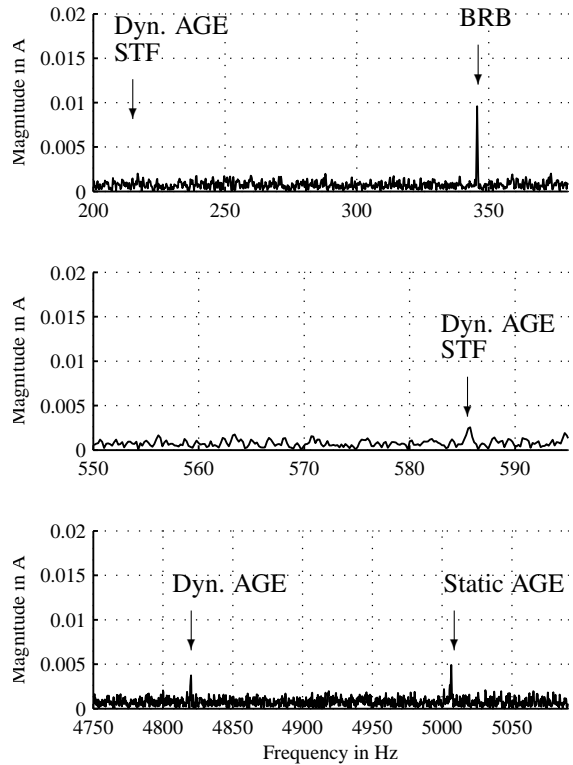
Figure 11. Spectrum of motor #4 in delivery state

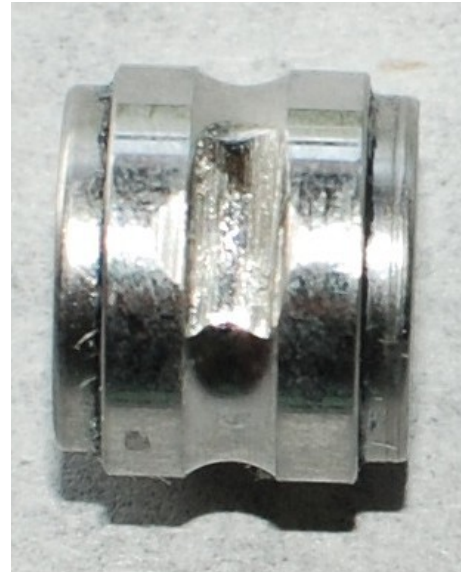
The damage in the inner ring is induced using an angle grinder, see Figure 12. The defective inner bearing ring was installed both in the front and in the rear bearing for separate test runs and for different motors. The current spectra

Figure 12. Inner ring BRG damage

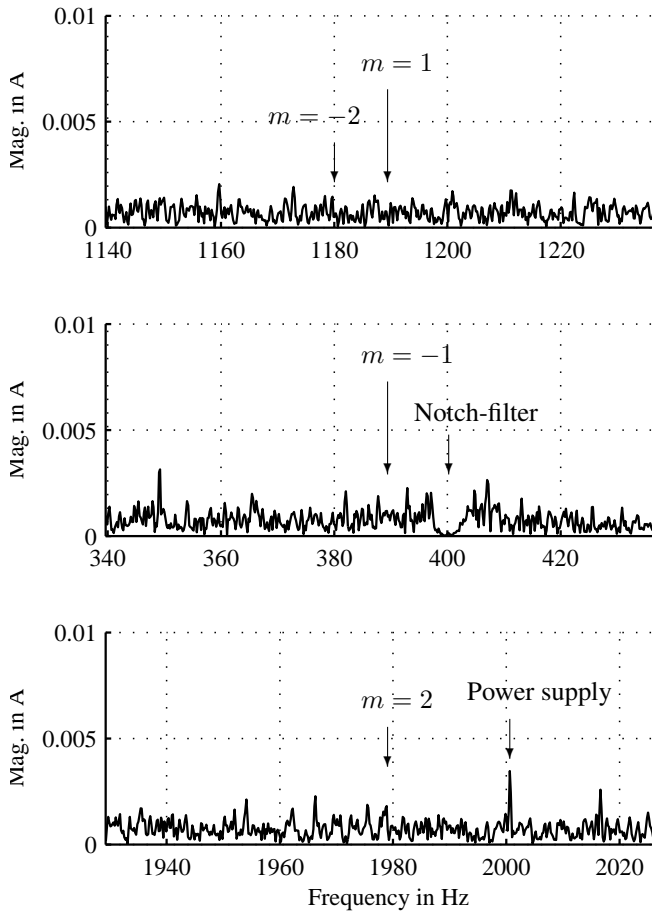
around the calculated characteristic fault frequencies for the inner ring damage (installed in the rear bearing) are shown in Figure 13. The characteristic fault frequencies, the Notch filter frequency and the peak caused by the power supply are marked. Unfortunately, the defective bearing can not be detected using the Fourier transform of the current signal with the proposed sensor concept. No increased current magnitude is visible in the spectra at the expected characteristic fault frequencies. Furthermore, extensive scanning of the current spectra show no other differences compared to the spectra obtained using motors in delivery state. The results are

repeatable by installing the damaged inner ring in a different motor or in the front bearing. The conclusion has to be that the defective inner bearing ring can not be detected in the current spectra using the magnitude of the characteristic fault frequencies for this motor.

Figure 13. Inner ring BRG damage

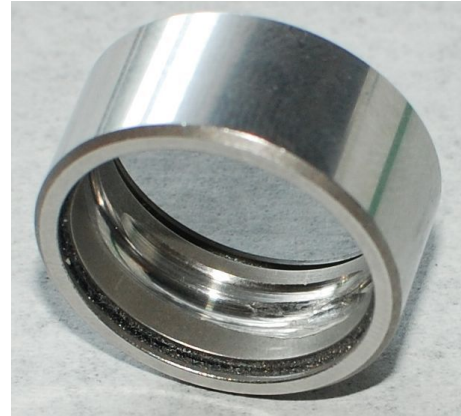
The damage in the inner ring is induced using an angle grinder, see Figure 14. As done with the damaged inner ring, the defective outer bearing ring was installed both in the front and in the rear bearing for separate test runs and for different motors. The current spectrum in the region of the characteristic fault frequencies given in Table 2 is shown in Figure 15 for a damaged outer ring in the front bearing. The characteristic fault frequencies and the peaks caused by the power supply are marked. The results for the outer ring bearing damage is equal to the result obtained for the inner ring damage, no expected peak is visible, leading to the conclusion that this failure case can not be detected in the FFT spectra of the current signal. The results can be reproduced if the defective

Figure 14. Outer ring BRG damage

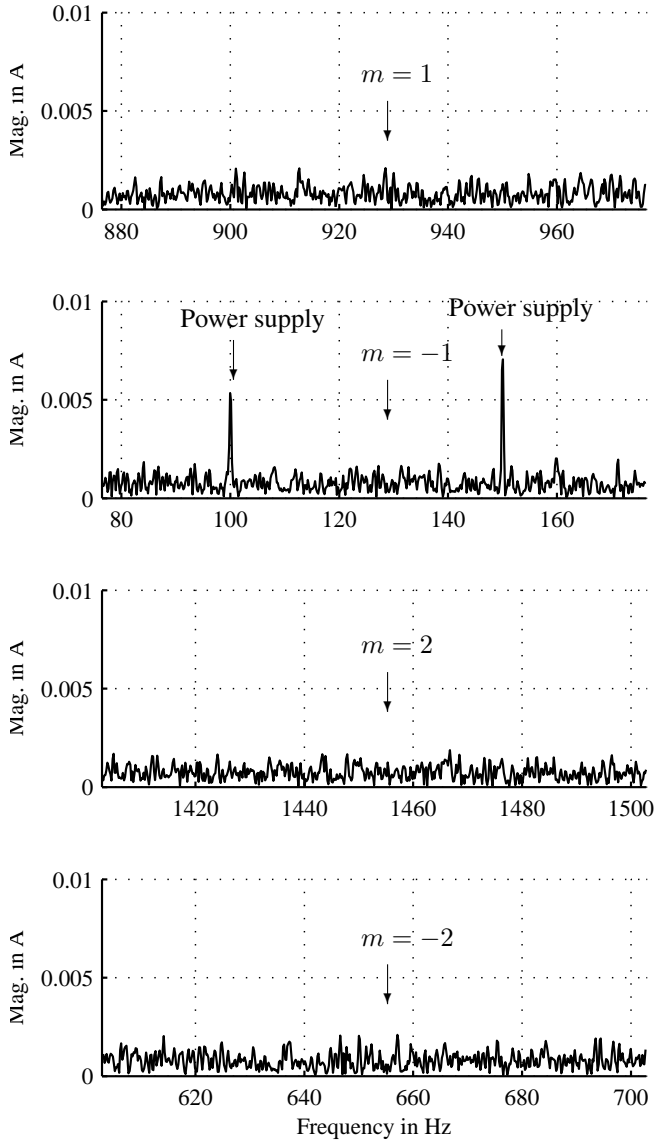
The conclusion that the bearing damage for this particular asynchronous motor can not be detected in the Fourier spectra of the current signal could be confirmed running the motor at a different operating point. To do so, the airflow was reduced to 218 l/s, forcing the air regulator to increase the resistance for the air flow. No peaks occurred in the spectra. The plots are spared out here since no additional information are found therein.

Figure 15. Outer ring BRG damage

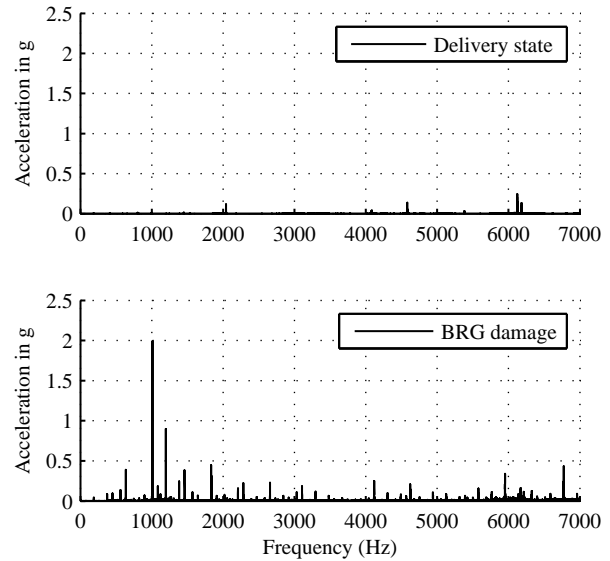
The frequency spectra of the radial acceleration signal are shown in Figure 16. The upper plot shows the acceleration for a motor in delivery state, the lower for a motor with defective bearing. The acceleration is much higher for the damaged bearing with many additional peaks. However, the acceleration phase of the rotor axis in radial direction is too short to cause a movement of the axis which could be detected due to changes in the air gap using current sensors. The too short acceleration phase is the result of the fast rotating motor axis.

Figure 16. Acceleration signal for motor in delivery state and with defective bearing

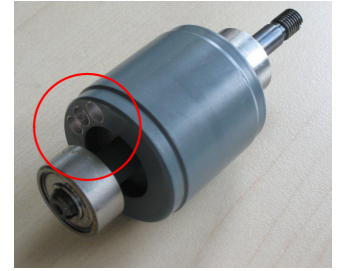
Figure 18. Drill holes

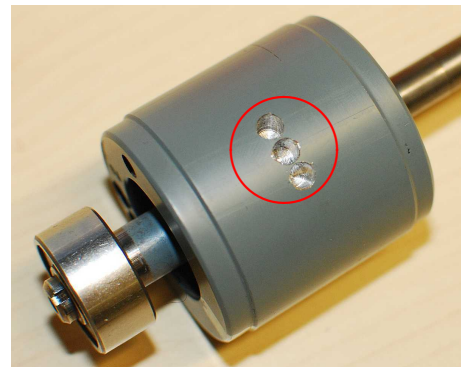
Figure 19. Rotor unbalance in BRB test

A broken rotor bar (BRB) is a fault in the electrical part of the rotor. This fault is artificially induced to the motor by drilling holes through the bars, see Figures 19. During operation, a BRB fault can e.g. occur due to overloading or due to mechanical stress causing cracks in the rotor.

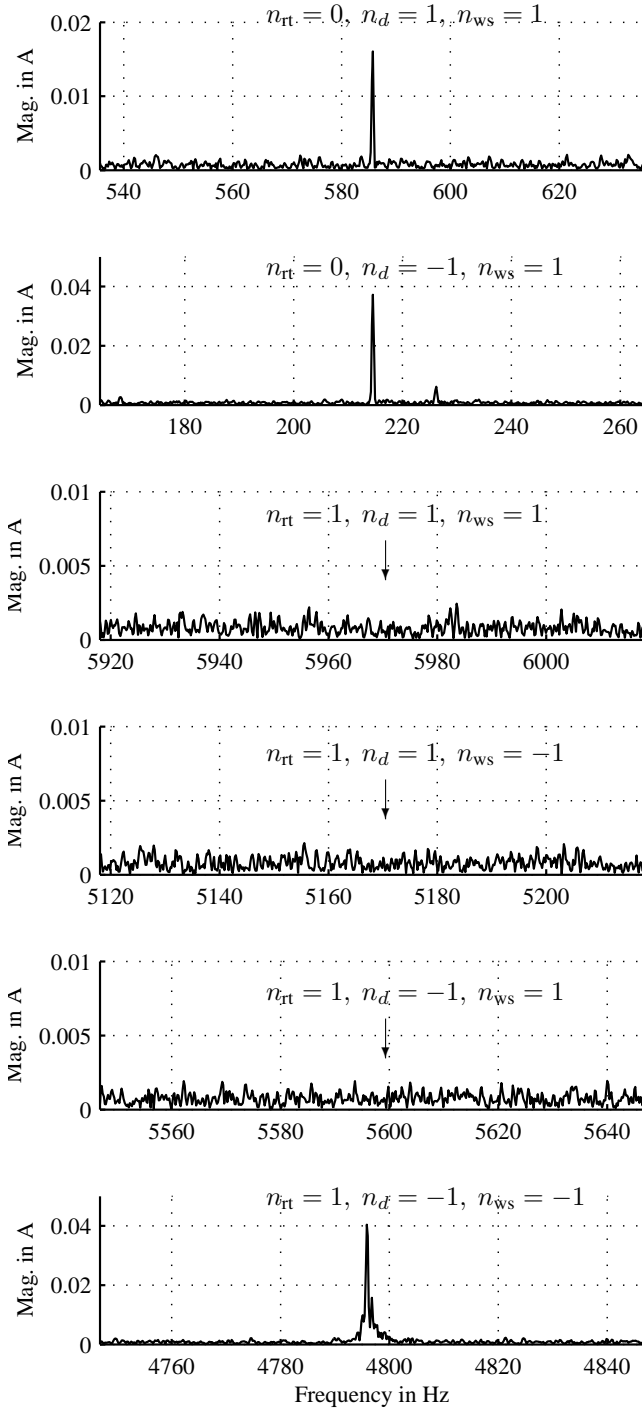
Figure 22. Three broken rotor bars

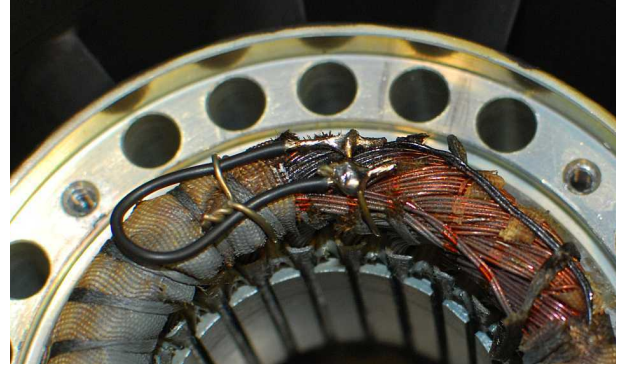
stator isolation is damaged by overheating, a short circuit can occur. Therefore, this fault case is artificially induced to the motor, see Figures 23.

Figure 23. Stator winding fault

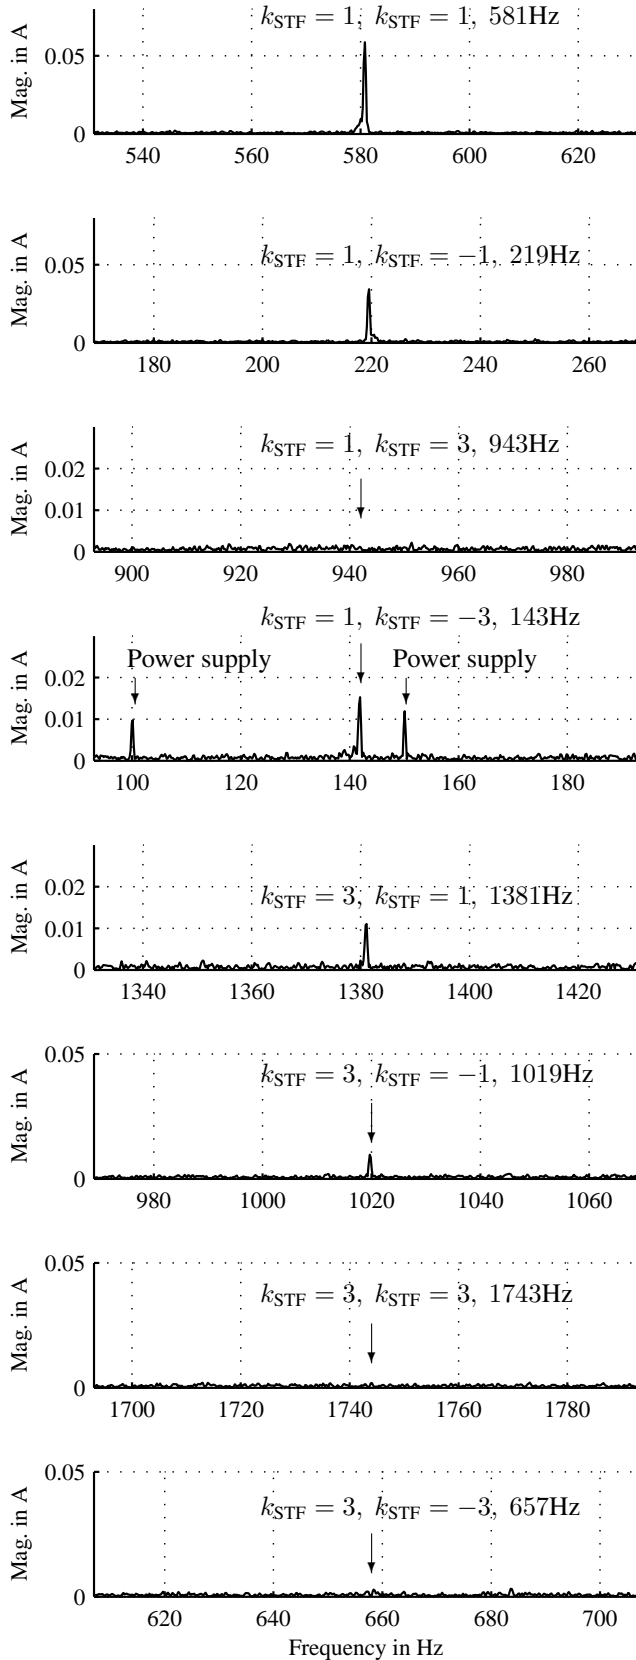
The spectrum for the stator winding fault is shown in Figure 24. Note the adjusted magnitude axis. Obviously, the fault can easily be detected. The maximum current magnitude is approximately 80mA at 581Hz, which is much higher than in the spectra in delivery state, as shown in section 4. Furthermore, other peaks at characteristic fault frequencies are distinctive. The peaks at 221, 143, 1381 and 1019Hz are also suitable for the detection of the STF. In summary, the detection of this particular fault case of the electrical part of this

Figure 24. Spectrum for STF

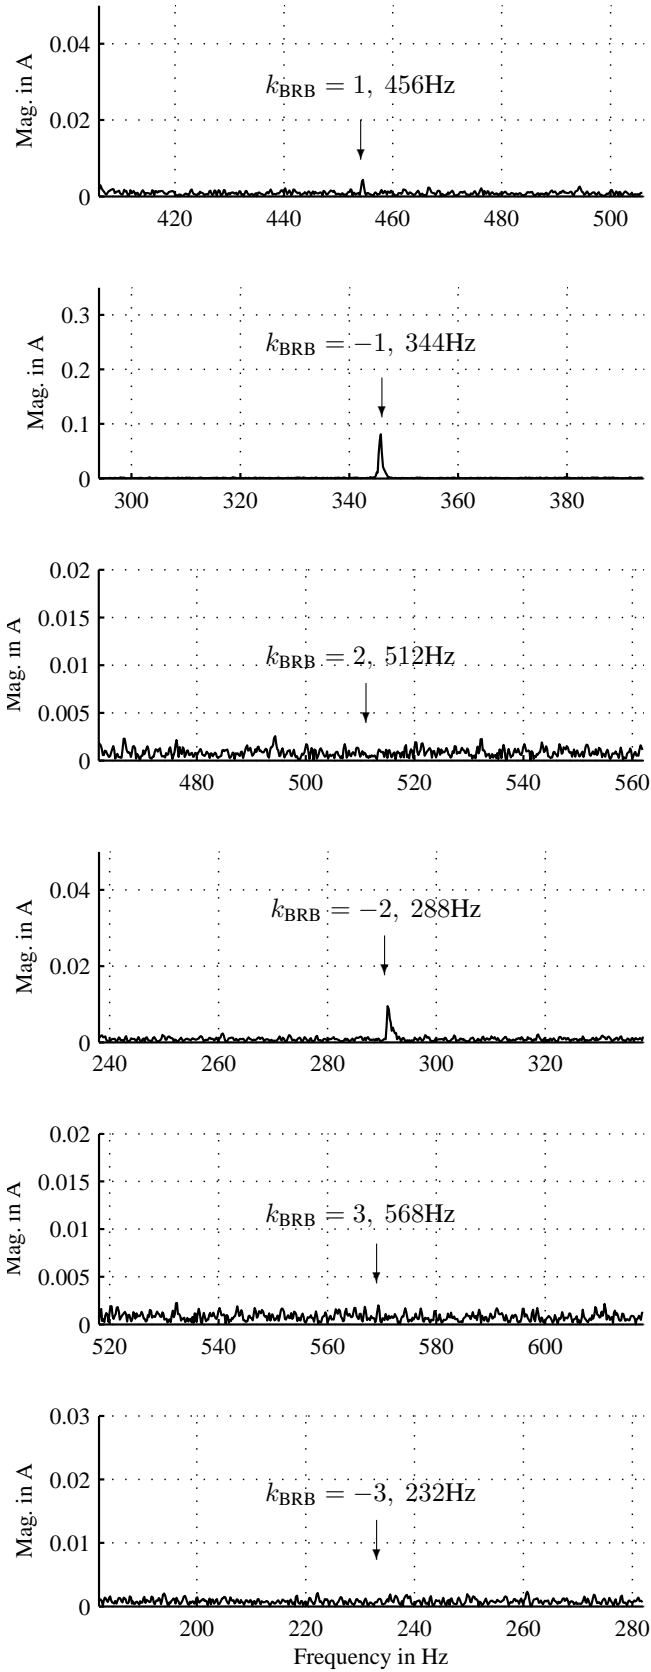
Figure 25 shows the spectrum for a BRB fault with one rotor bar drilled through. Note the adjusted magnitude axes while comparing the peaks to those of motors in delivery state as shown in section 4. Clearly, the damaged rotor causes the characteristic fault frequencies of this failure case to be measurably increased. This means that this fault case can be detected even in case of very low damage level. Figure 26 shows the spectrum for increased damage level. For this test run, three rotor bars are drilled through, as shown in Figure 19. It is obvious, that the peaks at the characteristic frequencies are higher than in the test run with one damaged rotor bar, the magnitude axes are unchanged in this comparison. This proves that the features extracted from the Fourier transformed current signal can be used to determine the health grade of the rotor bars. The tests were repeated using the damaged rotor in three different motor housings. The results shown in this section could be confirmed. The current signature at the characteristic fault frequencies of a BRB depend on the damage grade of the rotor and are not affected by the stator. Since this particular fault case is non reversible, only

Figure 25. Spectrum for BRB, 1 bar

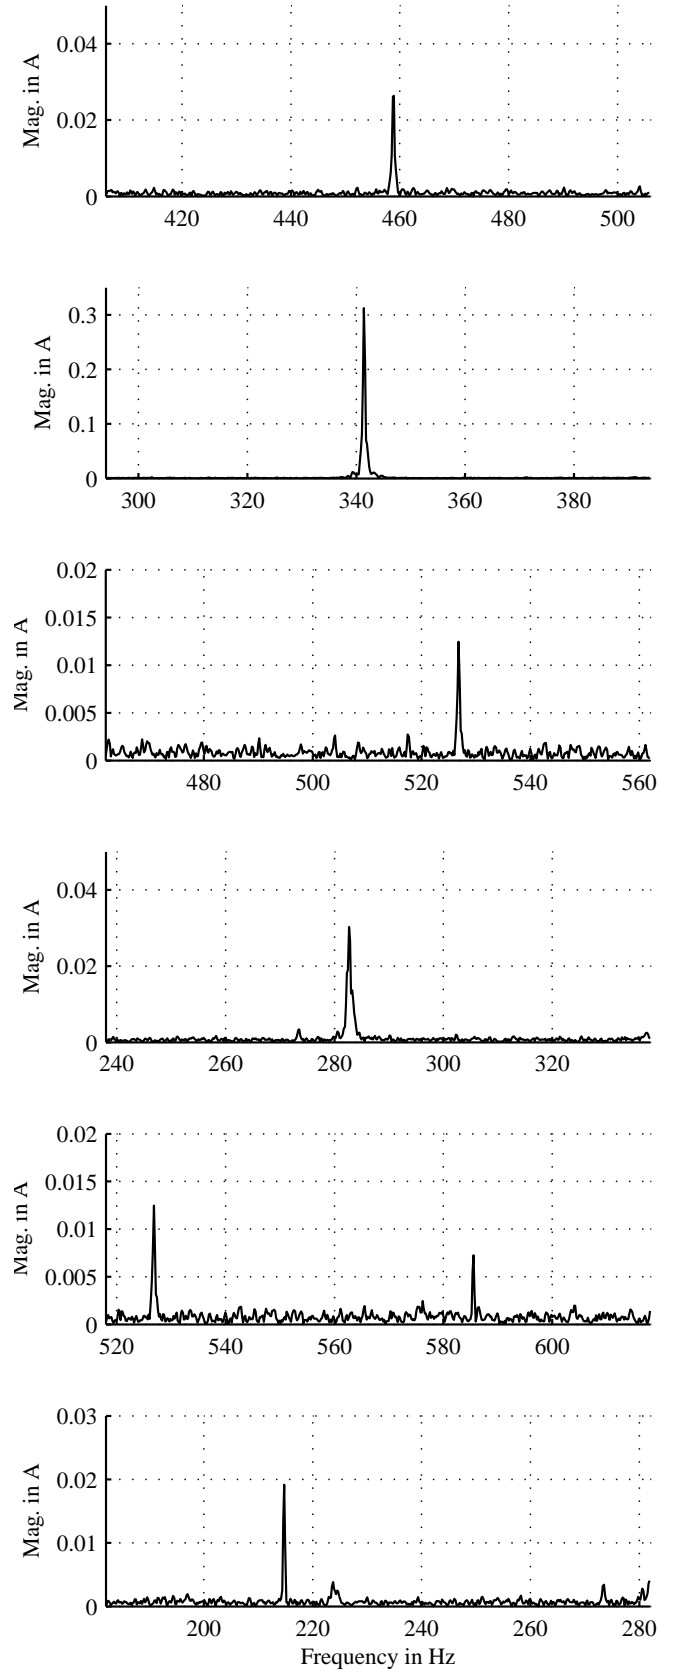
Figure 26. Spectrum for BRB, 3 bar

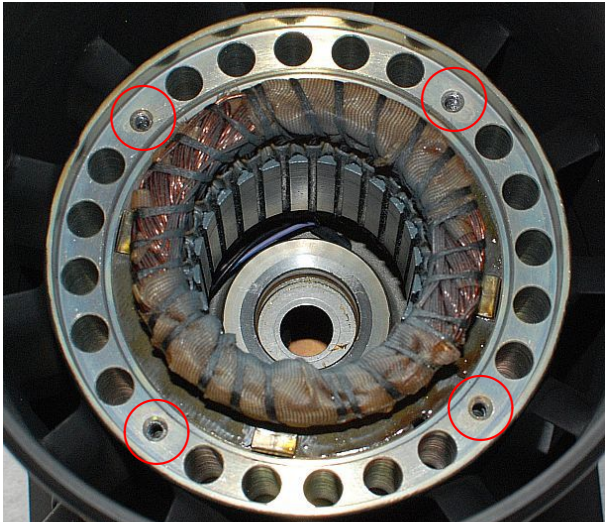
A static air gap eccentricity (AGE) is a fault in the mechanical part of the motor. A static AGE occurs if rotor and stator are statically misaligned. This means that the rotation axis of the rotor is out of alignment to the stator axis. This causes changes in the magnetic flux, leading to an induced current which can be measured by monitoring the motor line currents. For the tests in this research work, the fault is artificially induced by installing spacers under the front bell. This causes the front bearing to be tilted. The spacers are installed in the screw holes, which can be seen in Figure 27. For the testing, different sized spacers at different number of screws were used, see Table 6.

Figure 27. Static AGE fault

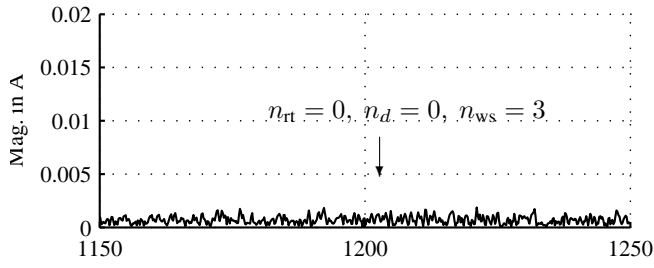
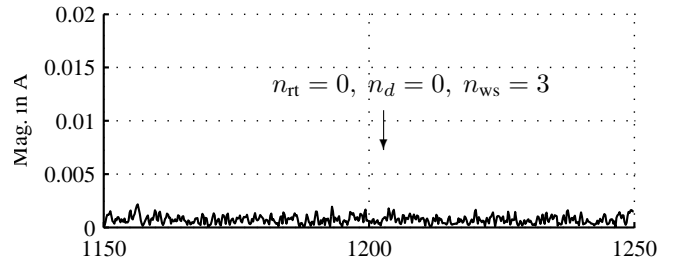
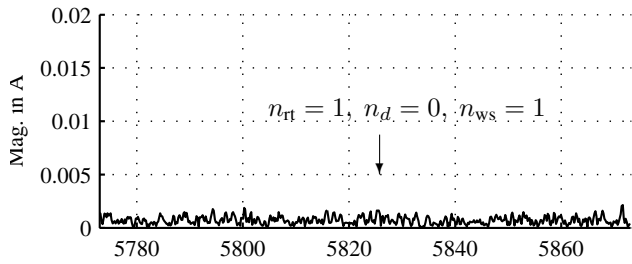
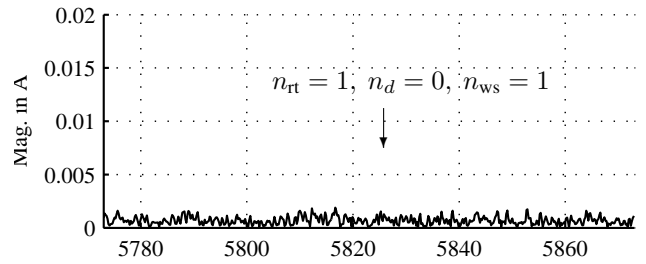
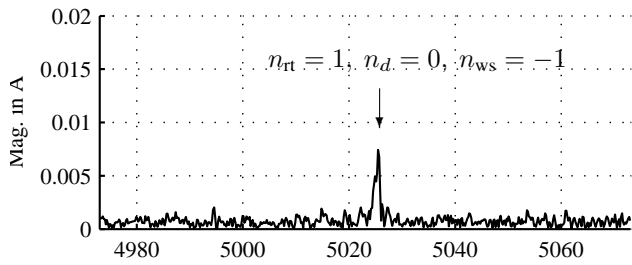
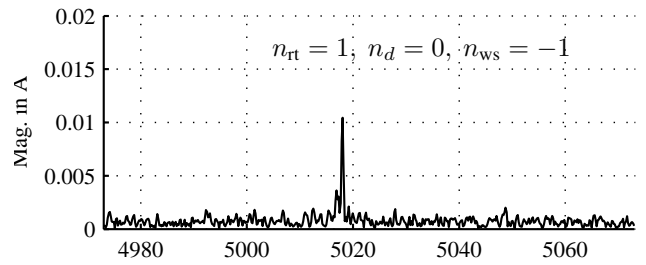
Figure 28 and Figure 29 show the spectra for the static AGE fault cases #1 and #3, as given in Table 6. The results in this section are measured using motor #2, whose reference spectrum is shown in Figure 9. In delivery state, the peak at approx. 5023Hz has a magnitude of less than 5mA. The magnitude of this frequency is increased with the spacers applied to the front bell. For test scenario #1 the magnitude is approx. 7mA and for scenario #3 it is above 10mA. The static AGE fault can clearly be detected using the Fourier spectra of the line current. Furthermore, the damage grade can be evaluated. The frequency which can be used for detection of the static AGE fault clearly is around 5023Hz since the other peaks show no modification due to the spacers.

Figure 28. Static AGE case #1

Figure 29. Static AGE case #3
