Fabrication of a Multi-Physics Integral Structural Diagnostic System Utilizing Nano-Engineered Materials

Seth S. Kessler¹, Ajay Raghavan¹, Christopher T. Dunn¹,
Sunny S. Wicks², Roberto Guzman deVilloria² and Brian L. Wardle²

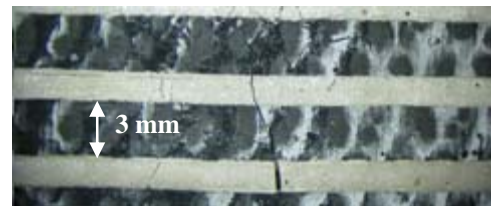
Figure 3: Photograph under microscope of impacted region of FFRP laminate. Painted silver electrodes are 1.5 mm wide and spaced 3 mm edge-to-edge.

Initially a single FFRP laminate (114 x 25 x 3 mm) was tested to prove the concept. Silver-ink electrodes were painted onto the specimen surfaces using simple tape masks (Figure 3). On the top plate surface, 14 parallel conductors were patterned in the short-dimension. On the opposite surface, 4 parallel conductors were patterned in the long dimension (so that they were perpendicular to the top side conductors through the thickness). These traces were all 1.5 mm wide and spaced 3 mm edge-to-edge. Prior to testing, the electrical resistance was measured using a Fluke 189 model multimeter with resolution 0.01 Ω and accuracy of $\pm 0.05\%$. Initial data showed significant variability when probing directly on the silver traces. Subsequently, a procedure was developed to bond thick gauge wires to the traces using silver epoxy, resulting in $< 1\%$ change ($< 0.1 \Omega$ for $\sim 10 \Omega$ trace) across 10 repeat trials. The specimen was centrally impacted with a 13 mm diameter steel ball at using a guided dropped weight to initiate damage. Following impact, post-damage resistance measurements were collected again for each possible combination.

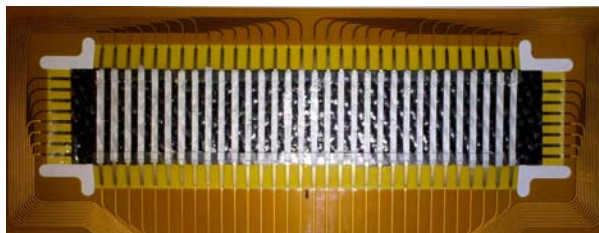
Figure 4: Photograph of flex-frame with FFRP sample

Next, rather than using soldered wires connect to the traces, a single double-sided copper-coated-Kapton w/coverlay flexible circuit was designed to make connections with the direct-write (DW) traces. In a processes developed by the investigators during the course of separate research, the flex circuit was bonded to the specimens first, then the DW traces were applied onto the specimens, including overwriting the flex-circuits (which included alignment marks). The flex circuit was designed in the shape of a rectangular frame, with flaps on all 4 inside edges with exposed pads for the DW process. The specimens fit inside the frame window with the top and bottom flap overlapping onto the front of the FFRP, and the left and right flap overlapping on the back of the FFRP. Traces are then routed along the edges of the frame to an 80 pin connector located on a bottom tab for hardware connection. This “flex-frame”, as seen in Figure 4, provides reliable, durable and consistent electrical continuity from traces to hardware, specifically because it eliminates all contract resistance issues. Finally, a PCB was designed to mate with this flex-frame, containing switches to multiplex the channels and simple and reliable connections for a multimeter probe and PC readout. After being instrumented, each FFRP specimen was progressively impacted at 15, 30 and 45 ft-lbs, using the same guided dropped weight setup, with in-and-out-of-plane resistance measured after each subsequent impact.
