Detection of CH-53 swashplate bearing deformation - from a 3D dynamic model to diagnostics

ABSTRACT

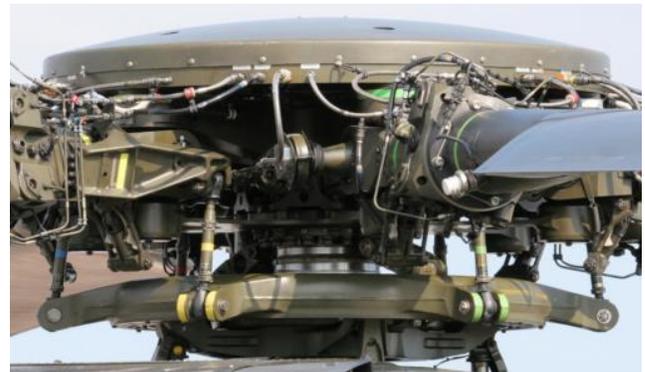
The swashplate is a device used for transmitting control inputs to the blades (see Figure 1). Therefore the swashplate bearings are safety of flight critical components. The swashplate of the CH-53 is constructed of two angular contact ball bearings supported by two spacers- internal, between the static inner rings and external, between the rotating outer rings (see Figure 2).

Figure 1. Sikorsky CH-53 swashplate; www.airliners.net

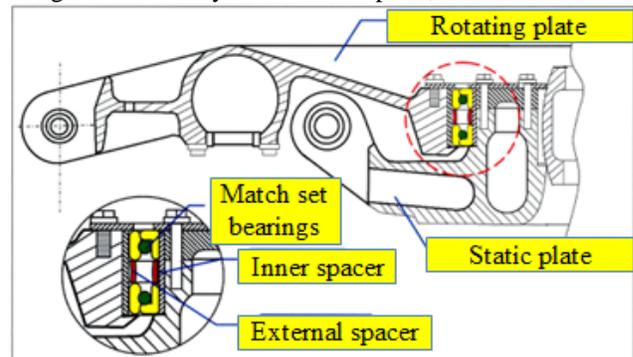
Figure 2. Swashplate cross section

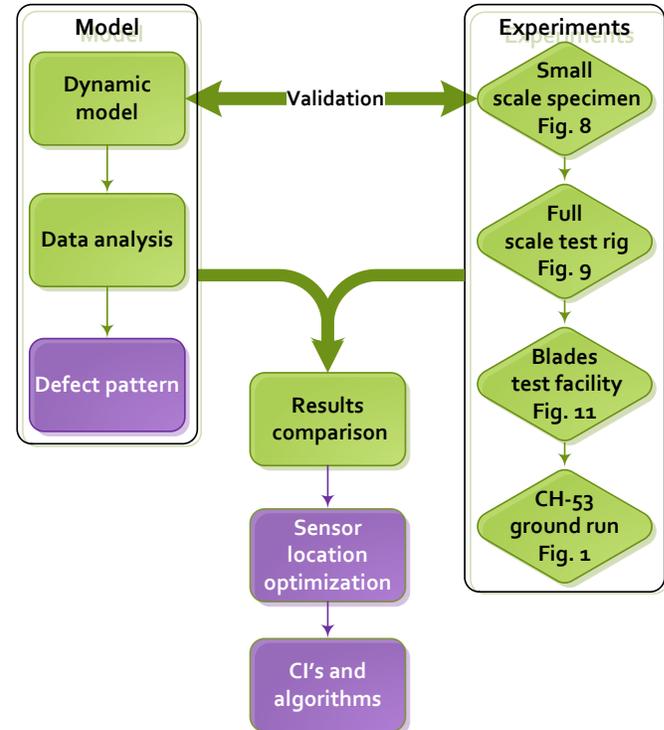
Pattern of bearings sub-components deformations are not thoroughly investigated, hence the need to study the defects signature. A new 3D dynamic model (Kogan et al., 2012) has been developed as a tool for investigation of faulty bearings behavior. As shown in Figure 3, time history data generated by the model was analyzed in order to define the fault expected pattern. Vibration signals generated by three test systems will be analyzed based on the model results in order to recognize the fault signature. At last, diagnostic algorithms will be applied to vibration data acquired from a CH-53 swashplate. The obtained signature will be compared to the validated dynamic model pattern to define the algorithm and the condition indicators of the fault.

Figure 3. Research flow chart

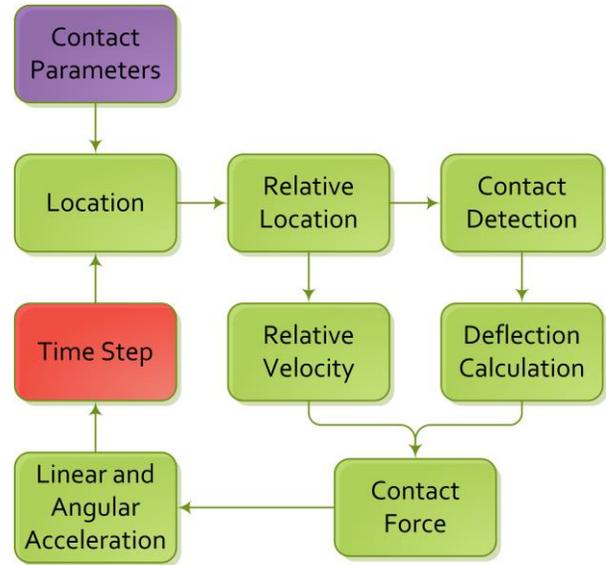
The presented equations describe the motion of all the modeled bodies and are solved using time steps (see Figure

4). In each time step, the solution of the equations is based on the previous time step solution, assuming a constant acceleration.

Figure 4. Simplified model algorithm

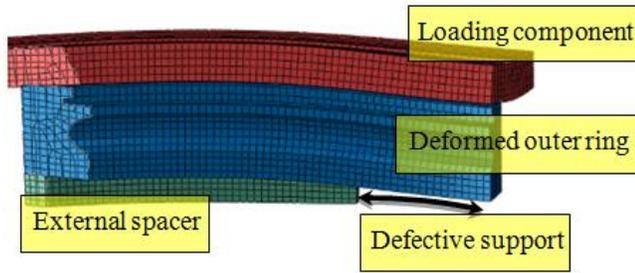
The failure investigation showed that the external spacer collapse separating the duplex ball bearing outer rings, led to damage of the upper bearing. The deformation of the outer ring was calculated using finite element analysis (see Figure 6). It was found that the lack of proper support causes local deflection in the axial direction of the outer ring of the top bearing. The deflected geometry was implemented in the dynamic model.

Figure 6. Structural defect finite element model

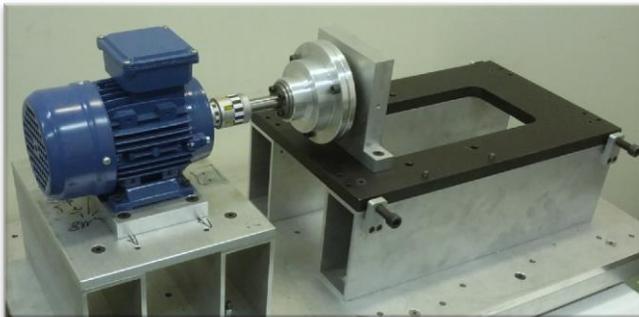
The small scale specimen is a kit of a generic test rig. The rig, shown in Figure 7, is a versatile platform built to study the signatures of common machinery faults. It has simply operated replaceable kits designed for fast experiments and simulation of a wide range of faults.

Figure 7. Generic test rig with the small scale specimen kit

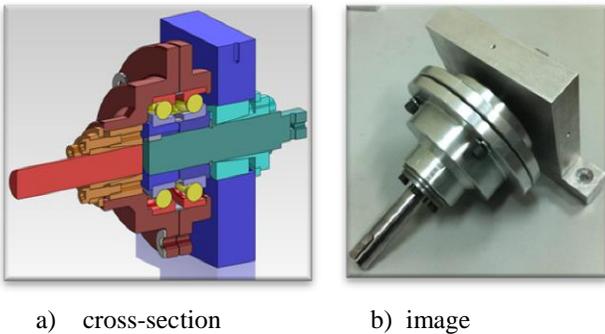
Figure 8. Small scale specimen

The specimen, shown in Figure 8, is constructed of two axial unidirectional ball bearings (NSK 7208BWG) separated by the examined spacers (static internal spacer and dynamic external spacer). The bearings are tightly set into aluminum cups. Pressure, simulating the spacers axial load, is applied by tightening the cups screws, forcing the two outer races onto the spacer.

Experiments included installation of the specimen with a healthy spacer and a number of spacers with faults of different sizes. Variation of tightening pressure resembled the spacers compression. A variable frequency drive controls the velocity of the electric motor and the shaft speed is measured by an optic encoder. Acceleration sensors can be mounted directly to the static shaft or onto the shaft housing, as shown in Figure 8a.

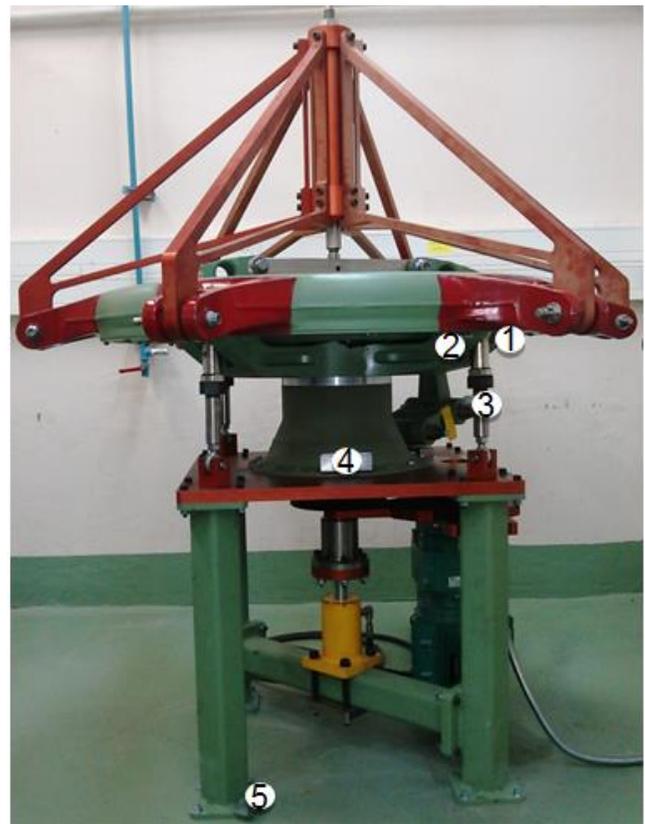
The rig, shown in Figure 9, is built around an original CH-53 swashplate. The rotating plate is set in motion by a transmission of gears and a belt driven by an electric motor. The motor is set to rotate the plate at 185 RPM, the CH-53 main rotor speed.

Figure 9. Full scale test rig and sensors locations

Simple and efficient change of swashplates was the main consideration in the design process. Already in-use loading configuration of such test rigs were examined (Bayoumi et al, 2008; Keller & Grabill, 2005). The chosen configuration, shown in Figure 9, has a reduced number of moving parts and lower weight due to reduction of the cyclic loading.

pressures and sensor locations. Five different sensor locations, shown in Figure 9, have been selected considering both operational and scientific applications. The operational locations are derived from helicopter already-in-use sensor brackets and considering maintenance simplicity in case of malfunction. The scientific application considers sensor location optimization and variation of the damping in the rig. Furthermore, transfer function influences the acquired signal. Data from different sensor locations can be used as a tool of comparison or for further analysis.

The acceleration PSD of the healthy bearing is presented in Figure 16. The PSD was calculated on the resampled acceleration acquired at sensor location 2 (as shown in Figure 9) in the bearing radial direction. As expected the bearing tones cannot be observed with a healthy swashplate bearing. Compared to the small scale specimen results, it can be seen that the vibration signature contains larger amount of information due to more inputs. This illustrates the expected difficulties in recognizing the pattern in a more realistic environment. Noises resulting from the transmission mask the bearing fundamental frequencies as shown in the multiple peaks appearing around the BPFO second harmonic (89.9). The model results point to the defect location but further analysis is needed in order to recognize the fault in complex mechanical systems.

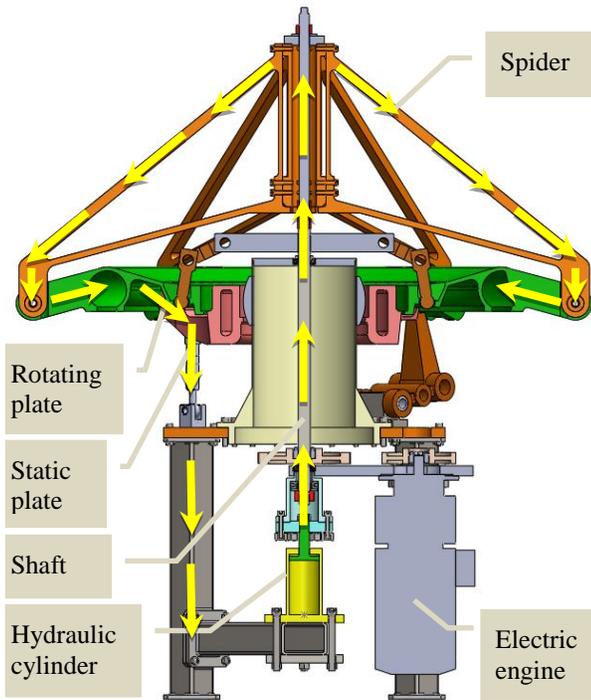
Figure 10 demonstrates the path of the load through the test rig. The simulation of the axial load on the swashplate is done using a hydraulic cylinder. The piston loads the main shaft that transmits the load to the rotating plate through the spider. The rotating plate transmits the load through the bearings to the stationary plate.

Figure 10. Load transformation over the test rig

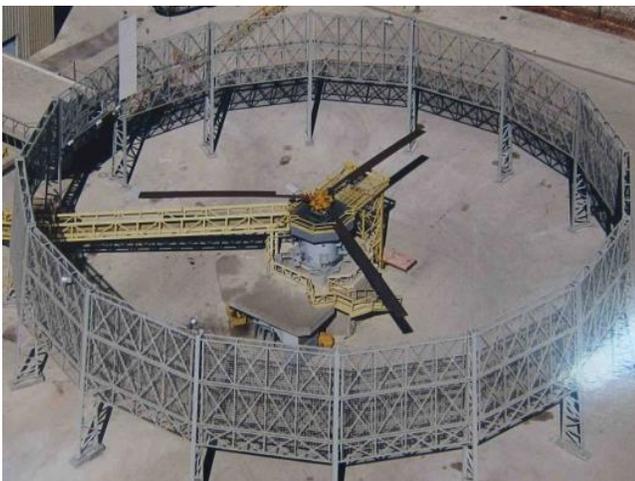
Figure 11. Helicopter blades test facility

Experiments at the helicopter blades test facility, shown in Figure 11, are planned to take place in the next phase. For facilitation of data comparison, the same acquisition system and sensors will be used.

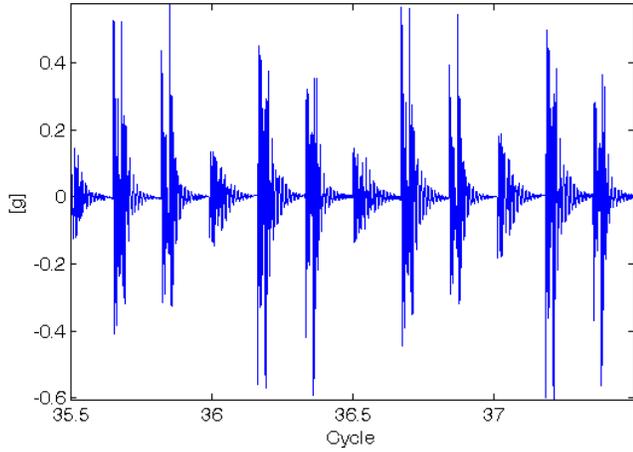
The inner ring center radial acceleration, shown in Figure 12, presents paired impulses that correspond to the impulses of the axial acceleration. However, the impulses that appear in the radial acceleration include shaft speed modulation, which is related to the defect location variation.

Figure 12. Small scale specimen bearing model results: inner ring radial acceleration

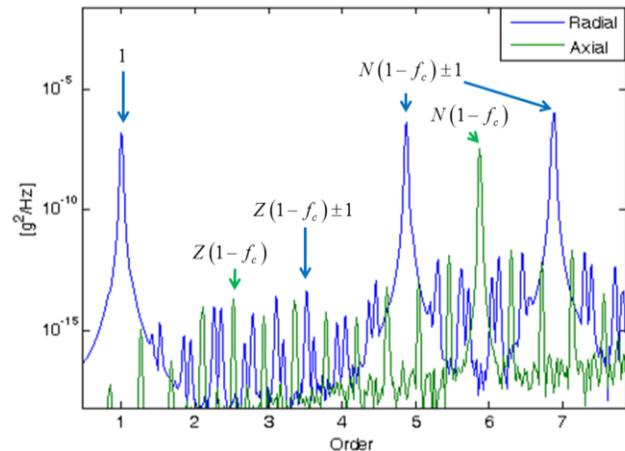
Figure 13. Small scale specimen bearing model results: PSD of the inner ring acceleration

The PSD of the axial acceleration of the inner ring center (see Figure 13) reveals peaks at the order:

The significant peaks of P_h appear when Z is a multiple of number of balls N , i.e. a harmonic of the Ball Pass Frequency Outer race (BPFO).

The effect of the major increase in the number of balls can be seen when comparing the axial acceleration of the small scale specimen bearing (Figure 13) and the full scale bearing (Figure 14).

The small scale specimen test results include examination of the fault influence on both radial and axial acceleration spectra (see Figure 15). The comparison between the spectra of the faulty supported bearing in the radial and axial directions reveals that the axial acceleration signal is dominant at the BPFO order harmonics and the radial acceleration signal is predominated by the shaft speed sidebands. These results correspond to the model results presented in Figure 13.

The model results, presented in Figure 13, show peaks at orders of $Z(1 - f_c)$ and of $Z(1 - f_c) \pm 1$. When Z is not a multiple of number of balls N , these peaks are low

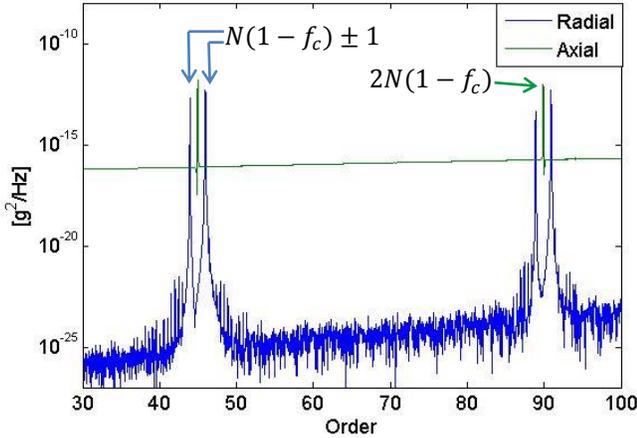
In agreement with the small scale specimen bearing results the radial direction significant peaks of P_s indicate sidebands of the shaft speed around a harmonic of the BPFO. The axial direction peaks of P_h indicate harmonics of the BPFO. The axial acceleration shows peaks at the BPFO harmonics (44.95, 89.91 ...).

Figure 14. Full scale bearing model results: PSD of the inner ring acceleration

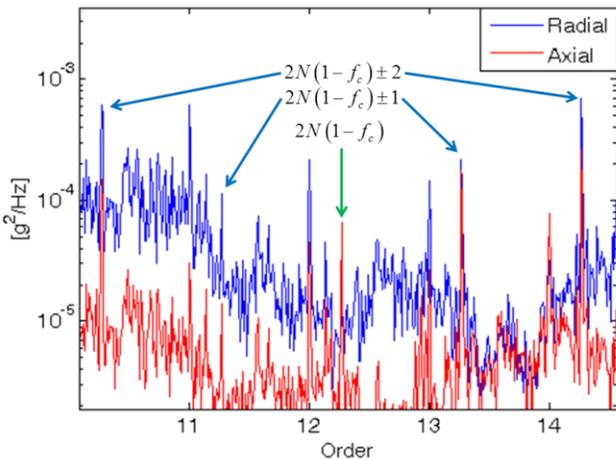
Figure 15. Small scale specimen results: PSD of the faulty supported bearing

compared to the BPFO harmonics and to their shaft speed sidebands. Therefore, those peaks cannot be observed in the test results and are probably masked by other sources of vibrations.

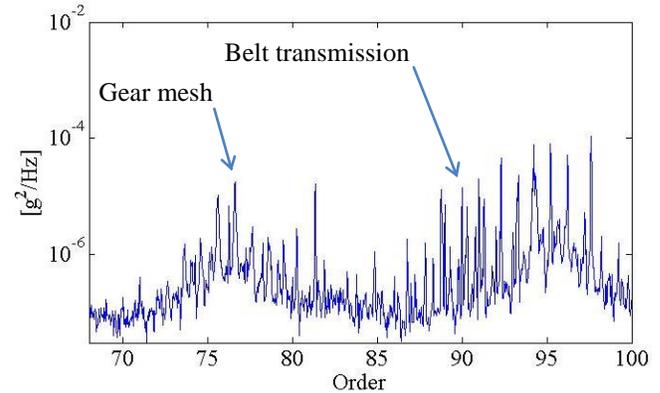
Figure 16. Full scale test rig results: order spectrum of the healthy swashplate acceleration
